EVALUATION OF THE CONSTANT PARTIAL
PRESSURE OXYGEN UNDERWATER BREATHING
APPARATUS.

Navy Experimental Diving Unit

Report No. 3-52

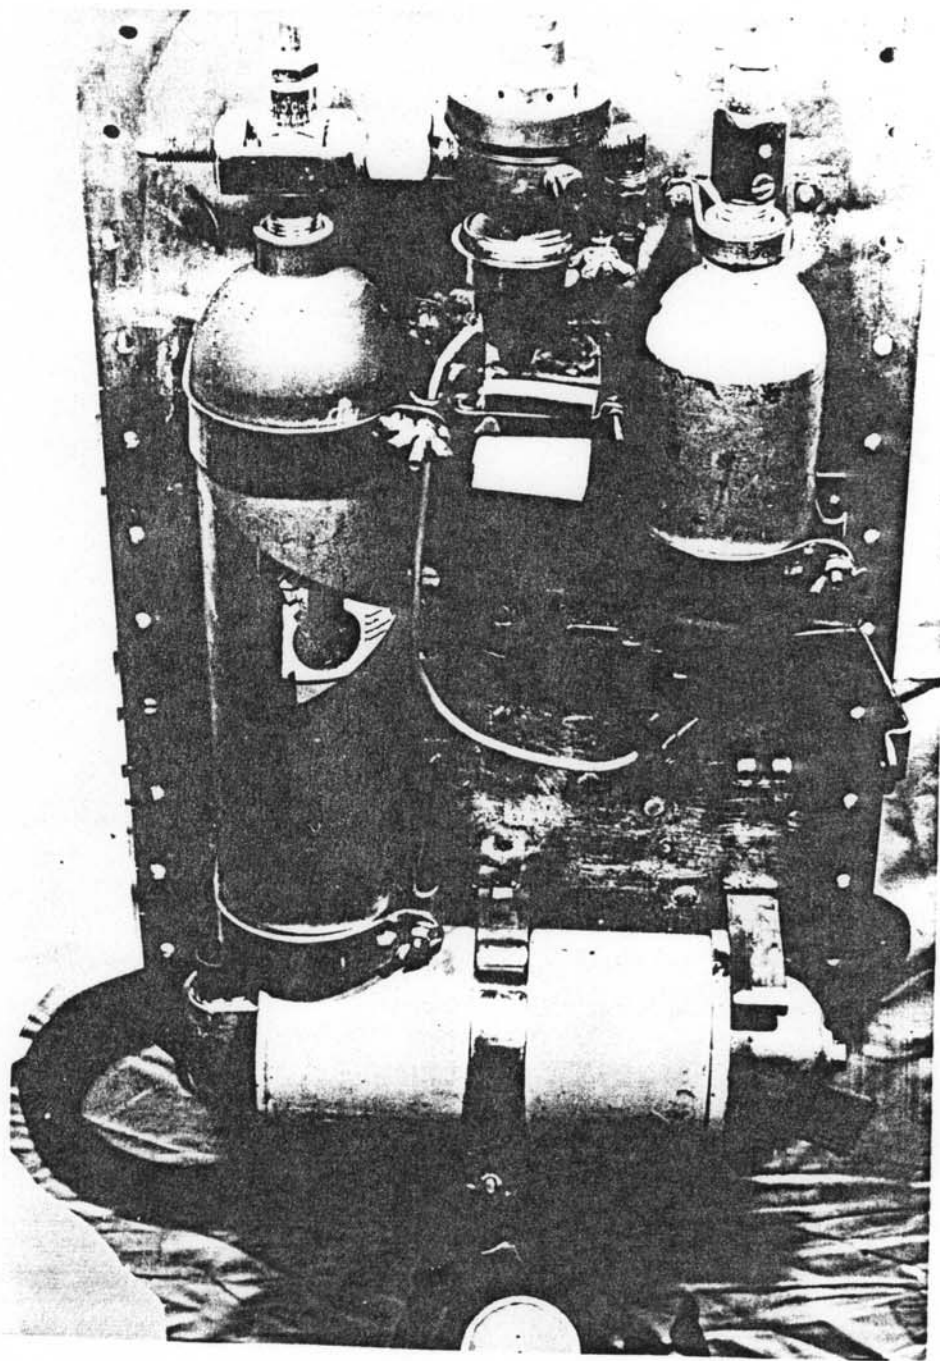
1. Photograph - Internal general arrangement
2. Photograph - Flasks, canister, and valves
3. Photograph - Battery pack and sensor unit
4. Photograph - Batteries
5. Diagram - Wiring schematic
6. Photograph - Laboratory calibration set-up
7. Graph - Oxygen partial pressure versus time of dive at varying depth for dive #1, 1/30/52.
8. Graph - Oxygen partial pressure versus time of dive at varying depth for dive #1, 1/31/52.
9. Graph - Oxygen partial pressure versus time of dive at varying depth for dive #2, 1/31/52.
